Technical Service Handbook

Model description: e-tron 230

Service info: Emergency call warning - static entry B18BD13 mobile phone aerial 1 for emergency call module, interrupt.

Transaction No.: 2071209/1

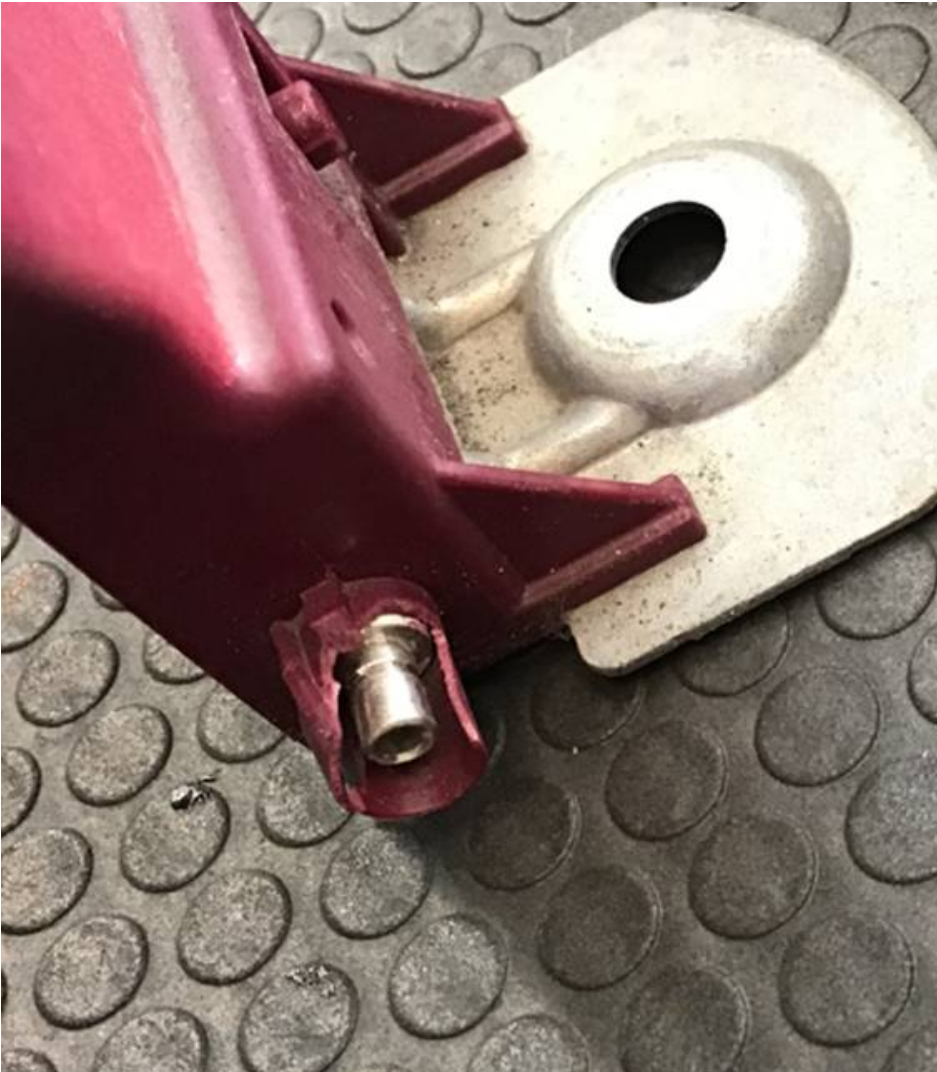
Figure 1

Open circuit in aerial wire for LTE aerial

- Check the electrical connector on the LTE aerial in the left rear area behind the bumper
- If there is damage present, as shown in figure 1, the fault is due to an external force, such as a rear-end collision
-

- No warranty claim can be made in this case.
- If the damage shown above is not present, proceed according to the instructions in Guided Fault Finding (GFF).
